PAPER 8

A CASE FOR TRENCHLESS TECHNOLOGY - MAHATMA GANDHI TRUNK SEWER REHABILITATION PHASE 2

Reudebaker Nel

eThekwini Municipality, Water and Sanitation Unit, Professional Engineer BSc Pr.Eng.

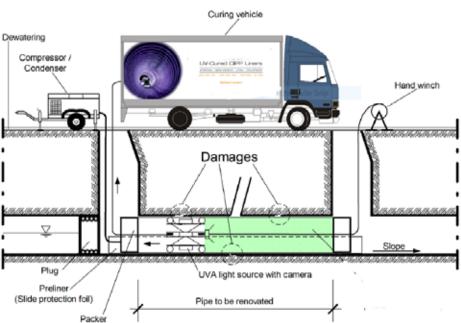
FIGURE 5: Diagram showing the cured in pipe liner instillation process cured by UV light

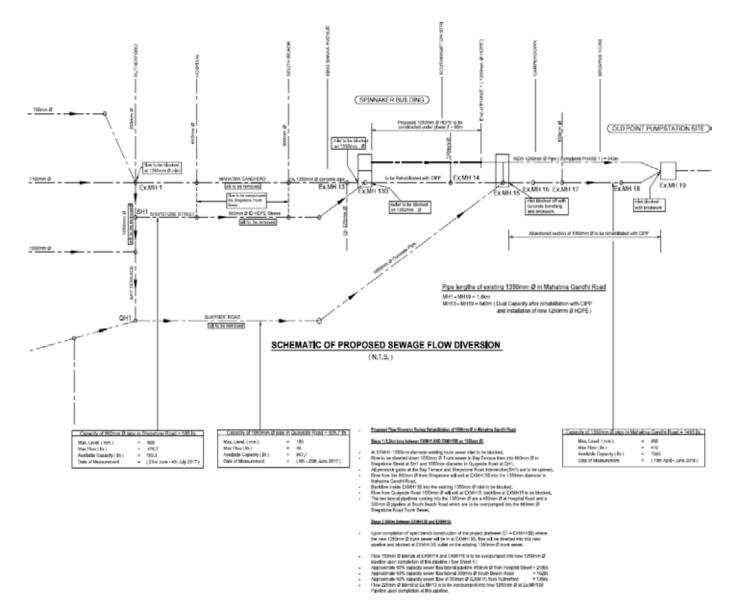
FIGURE 15: Flow diversion schematic and sequence of flow diversion to facilitate rehabilitation.

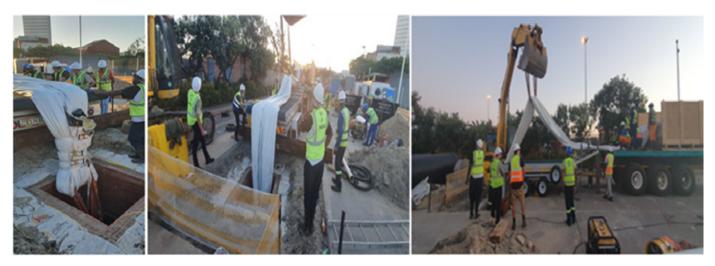
FIGURE 16: *CIPPL being inserted into a manhole*
