DRAWBACKS OF POTHOLE FILLING PROGRAMS AS A PREVENTIVE MAINTENANCE MEASURE: STUDY BASED ON NON-INTRUSIVE PAVEMENT DEFECTS INVESTIGATION

Christian A. MULOL

CSIR, Smart Mobility, Pavement Design and Construction

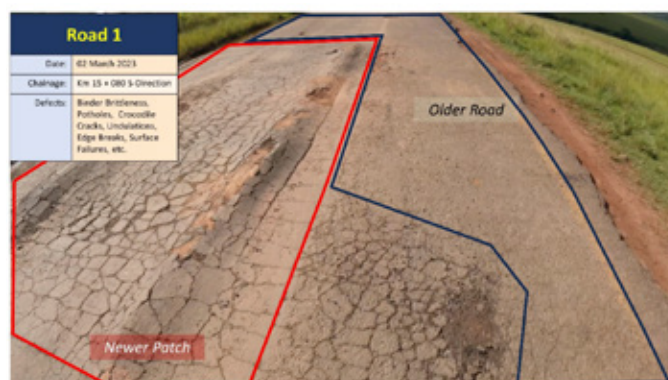
Before the future anticipated performance of any pothole repair could be predicted, the performance of the old patches was evaluated. As shown in Figure 2, it was often observed that poorly constructed patches invariably performed poorly than even the older pavement structure they were intended to improve. This is often the case due to substandard construction techniques, and the use of different materials than was initially used within the adjacent older pavement structure, leading to differential settlement, or differential consolidation. It should also be noted that pothole repairs are often confined, making the uniform compaction of the patched area difficult to achieve.

FIGURE 2: Road 1, Patch performing worse than adjacent older road

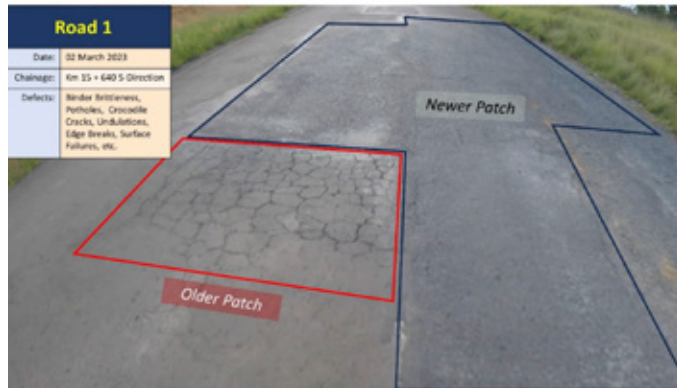
The other typical observation was that new pothole repair patches would sometimes highlight how old ones that were intended to serve the same purpose have underperformed and failed to improve the condition of the road. Hence, failing to prevent further deterioration in subsequent years. As depicted by Figure 3, the pothole repairs of previous years resulted in a patch marked as “older patch”, which could not prevent further failure in subsequent years. If the older pothole repair had been efficient, this would have assisted in preventing the new pothole repair, such as the one marked as “newer patch” in Figure 3.

FIGURE 3: Road 1, Older patch indicating poor performance.

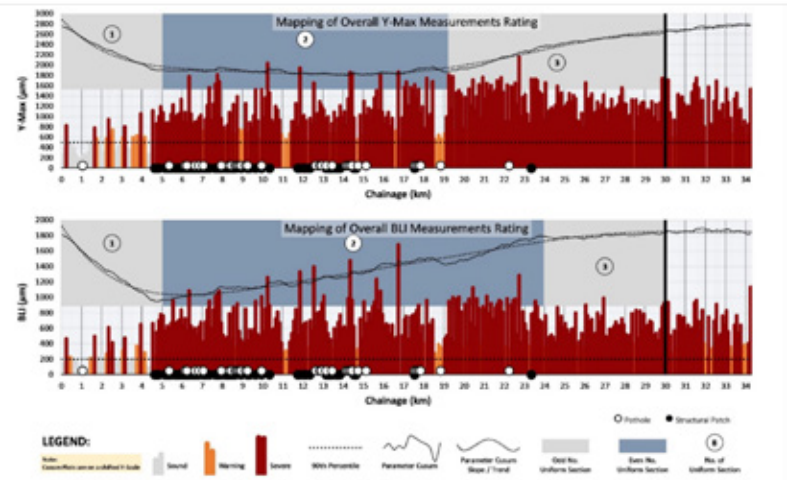
For Road 1, it was evident that from about km 4+500 to about km 10+500 and km 11+500 to km 14+500 that previous years’ pothole repairs (now evidenced by old patches) did not prevent the severe deterioration condition of the road, as illustrated by the dark brown Y-Max deflection bowl parameters recording over the given stretches in Figure 4. The BLI deflection bowl parameters were also dark brown over the same area of Road 1. This indicated that the previous years’ patching did not assist to prevent the deterioration of the base horizon of the pavement structure. The same pattern was observed for Road 3 in Figure 6, Road 4 in Figure 7, and Road 5 in Figure 8 as structural patching or pothole filling did not prevent the poor Y-Max and BLI readings.

FIGURE 4: Road 1, FWD strip map with mapping of potholes and structural patches.

The argument above is further substantiated by the fact that some sections of road without pothole failure of degree in excess of three (3), such as Road 1 from km 24+000 to km 30+000 (Figure 4), still recorded the severe Y-Max and BLI conditions indicating that they were already experiencing excessive deflection within their base layer horizon.

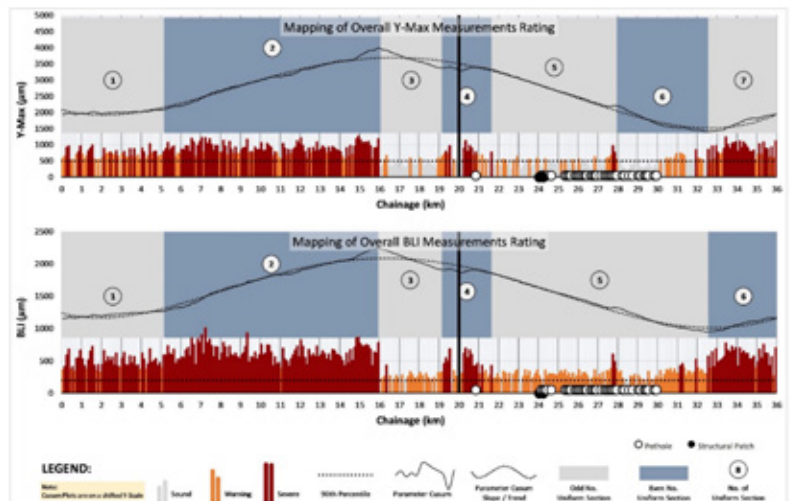
The only difference with Road 2 in Figure 5, was that the Y-Max and BLI deflection bowl parameter readings had a warning rating instead of the severe. However, even this warning rating is still not desirable.

FIGURE 5: Road 2, FWD strip map with mapping of potholes and structural patches.

For Road 2 in Figure 5, the warning rating condition of the BLI also indicates that the pavement is already in need of structural rehabilitation.

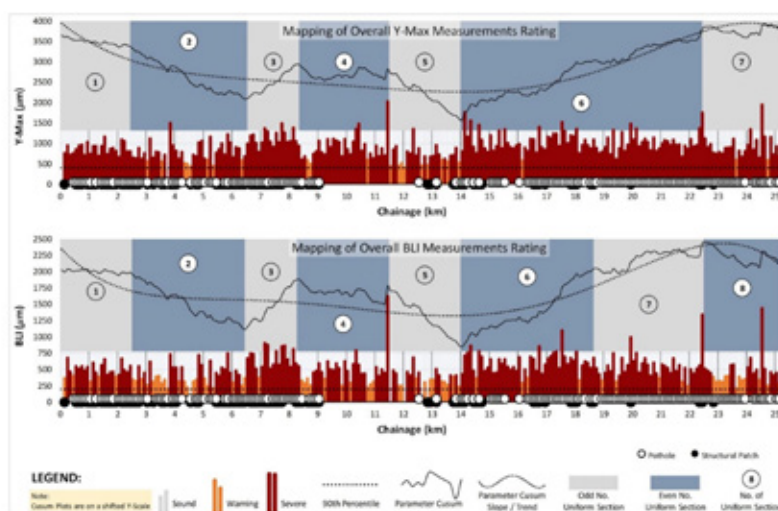
In some instances, potholes are only the symptoms, and the source of the problems lies deeper within the pavement. Such deeper problems are the reason why poorer Y-Max and BLI are still recorded even in the absence of potholes, as in the case of Road 4 from about km 9+200 to about km 12+500 in Figure 7. This also means that shallow pothole repairs will not necessarily eliminate the underlying and deep-seated source of the problem.

FIGURE 7: Road 4, FWD strip map with mapping of potholes and structural patches.

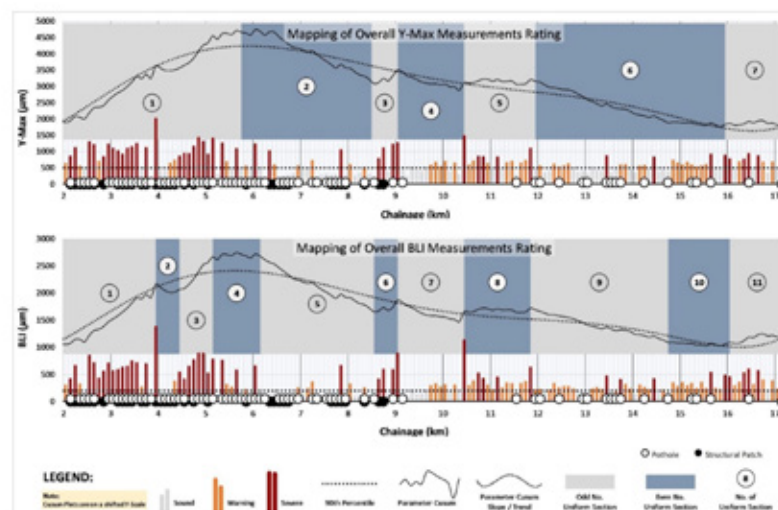
FIGURE 8: Road 3, FWD strip map with mapping of potholes and structural patches.

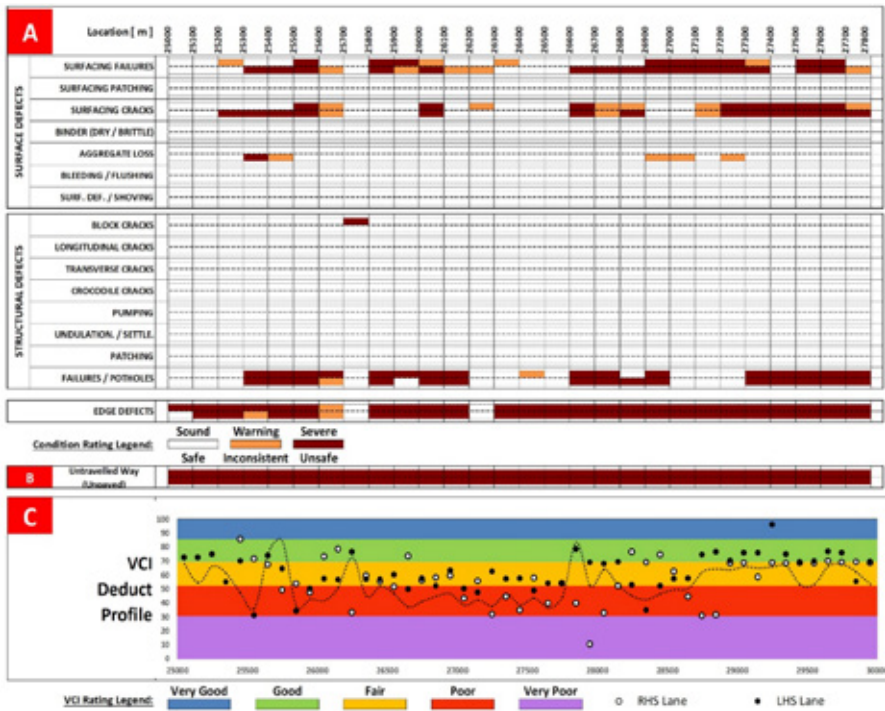
A more detailed analysis of Road 1's visual assessment between km 25+000 and km 27+800, as depicted in Figure 9, shows that attention should also be given to other defects. Block failures, surface cracking, surface failures, and aggregate losses might have been the defects that caused the initiation of potholes [Paige-Green et al, 2010]. Water ingress within the pavement structure through the surface cracks combined with traffic loading will always have the potential of reducing the structure bearing capacity and eventually lead to fine pumping and the formation of potholes. This has always been Emery's argument, as he alerted the road sector to the detrimental effect of water ingress through the passage created by surface cracks [1988].

FIGURE 9: Road 1, Extract of road defects mapping and VCI strip map.

It was also observed that the section with patches did not necessarily perform better than those without patches. As shown in Figure 9, other identified surface and structural defects were shown to be equally critical in influencing the deterioration of the pavement Y-Max and BLI deflection parameters. It can therefore be concluded that focusing only on potholes runs the risk of ignoring other defects that could be more revealing about the poor pavement layer conditions.
