## PAPER 16

# WIDENING AND STRENGTHENING OF THE EXISTING CERES VAN BREDA BRIDGE

**Dave Edwards<sup>1</sup> and Joseph Barnard<sup>2</sup>**

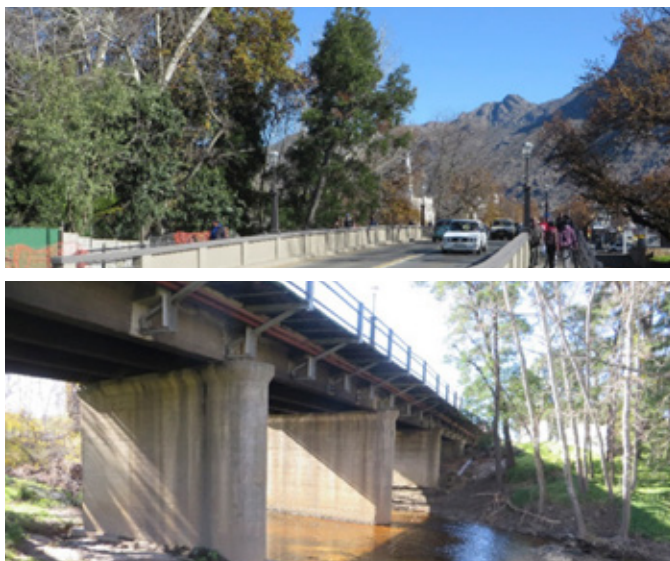
**FIGURE 3:** Van Breda Bridge (June 2016)

- To repair and enhance the riding quality of the surface, which had deteriorated over time. It was identified that the concrete topping slab was delaminating from the underlying beam structure.
- To widen the cross-section geometry of the bridge and accommodate two lanes with shoulders, and to provide space for cyclists and pedestrians.
- To increase the load capacity of the bridge to meet current standards. A 2013 investigation revealed that the structural capacity might have been as low as 66% of the TMH7 code requirement.

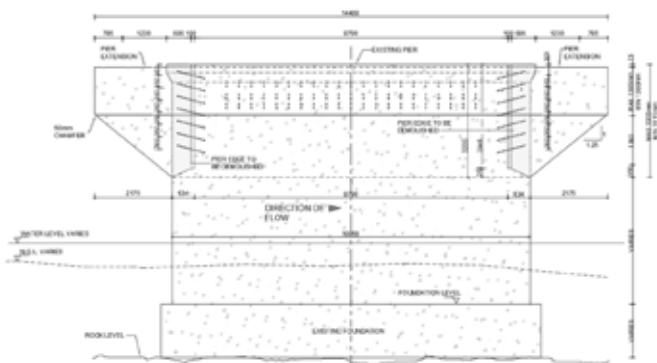
**FIGURE 6:** Side view of widened piers by means corbels tied to existing piers

The bearing capacities of the bedrock under the existing piers were verified and confirmed by the geotechnical engineer to be sufficient to withstand both the current and additional loads imposed by the new design. Consequently, widening the base of the existing piers was unnecessary. Instead, the piers were only widened at the top to support the new edge beams. This was achieved by means of widened corbels tied to the existing piers using dowels and post-tensioning. The corbels were reinforced and standardized across all piers to streamline the construction process, and minimizing the need for extensive river work and excavation.

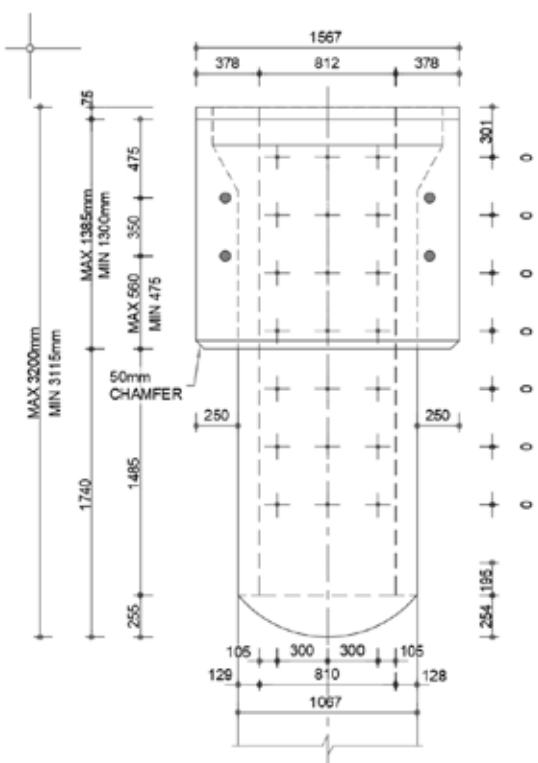
**FIGURE 7:** Cross-section through pier widening, showing post-tensioning

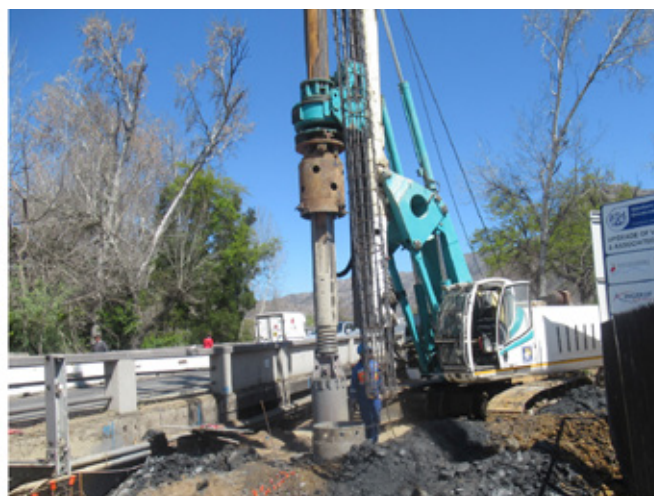
**FIGURE 8:** ODEX/Rota piles at abutment extensions.

The original intention was to extend the widened abutments down to the bedrock for foundation support. However, geotechnical investigations revealed that the bedrock was deeper than expected at both abutment ends. Excavating to these depths in the constrained areas, especially considering potential groundwater, was deemed impractical and unsafe, even with a caisson method. Consequently, the decision was made to use end-bearing pile foundations.

These were designed and constructed by a specialist piling sub-contractor, and were configured in sets of four at each abutment extension to carry the specified loads and plans. ODEX/Rota piles were selected for their suitability in riverine environments and their quicker establishment. Figure 8 illustrates the installation of one of these piles in close proximity to the existing bridge.

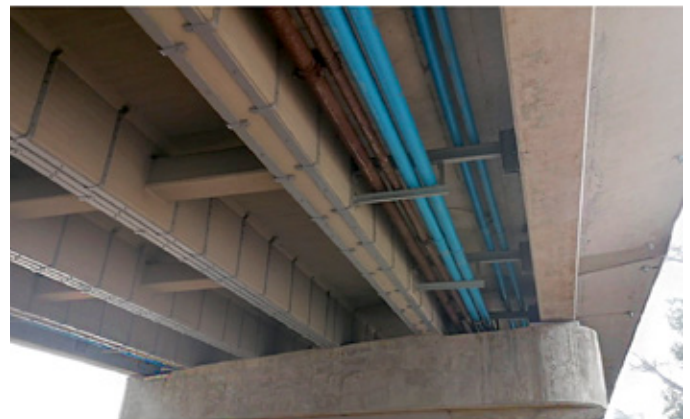
**FIGURE 12:** *Steel plates to the bridge soffits for strengthening*

This was achieved by bolting on steel plates to the soffit of the beam to act as additional tensile reinforcement, and to the sides to act as shear reinforcement. The effective depth of the beam and slab combination was then increased by means of first removing the original concrete skin that had delaminated, and constructing a thicker and more durable reinforced concrete slab which was dowelled into the existing deck slab with steel bars at a close spacing to act as shear connectors. A photograph of the steel plate reinforced original beams and conventional new edge beams is in Figure 12 below. The new supports to the existing and new services can also be seen.
