THE NEW SA PERMEABLE INTERLOCKING CONCRETE PAVEMENT (PICP) GUIDELINES

Neil Armitage & Motlatsi Monyake

University of Cape Town

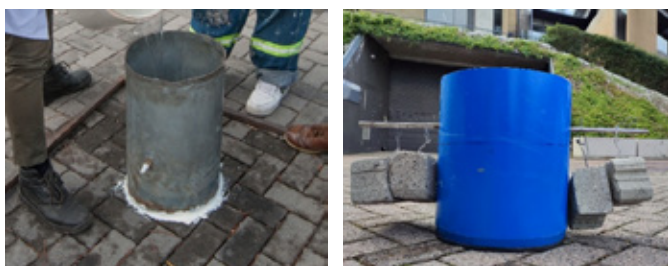
There is currently no universally accepted PICP infiltration test method. The most commonly adopted method appears to be the ASTM C1701/1701M: *Standard Test Method for Infiltration of In Place Pervious Concrete*, sometimes called the Single-Ring Infiltrometer Test (SRIT) because it only uses one ring as opposed to the Double-Ring Infiltrometer Test (ASTM D3385:2009) which is preferred for the measurement of soil infiltration rates (ASCE, 2018). There are, however, problems with the SRIT when used to measure infiltration rates in PICP. These include: leakage, marking of the surface, excessive water use, and the unacceptably long test time for partially blocked PICP. Most PICP testing in this project was carried out using ASTM C1701/1701M / SRIT with some minor modifications which was thus termed the Modified ASTM (Mod-ASTM) test (Figure 2).

FIGURE 2: ASTM C1781 test apparatus (left) and Mod-ASTM test apparatus (right)

The modifications included:

- The steel ring was replaced with a 500 mm long x 315 mm diameter unplasticized vinyl chloride (uPVC) pipe weighted down with small concrete blocks when in use.

- 10 and 15 mm head marks were made at the bottom of the ring to help guide the rate at which water was poured into the apparatus.
- The plumbers putty normally used to reduce water loss out of the bottom of the ring was replaced with a 10 mm neoprene foam strip glued to the bottom of the pipe.

- After experiencing unacceptably long test periods where it appeared that significant quantities of water were leaking out of the apparatus via the gaps between the pavers that could not be completely plugged with small neoprene pieces, the maximum testing time was limited to 15 minutes after which no further water was added. The timer was stopped when all the remaining water in the apparatus had infiltrated into the test spot. The total quantity of water infiltrated into the PICP was then determined by subtracting the remaining water determined with the aid of a measuring cylinder from the initial 18 L prescribed for the full test.

- ASTM-C1781-14a states that 3.6 L of water should be used for pre-wetting, however, when the Mod-ASTM test was carried out in combination with the Mod-SWIFT test, the latter was performed first which wetted the surface making the pre-wetting stage for the Mod-ASTM test redundant.

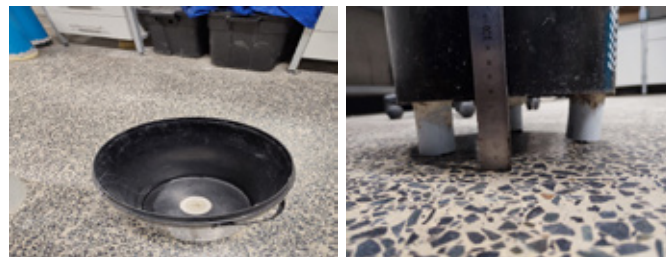
The other test that was used to determine the PICP surface infiltration rate was the Modified Stormwater Field Test (Mod-SWIFT, Figure 3). The Stormwater Field Infiltration Test (SWIFT) infiltration capacity is normally determined by counting the number of bricks wetted by 6 L of water

FIGURE 3: Mod-SWIFT test apparatus (not situated on a PICP)

In a bid to make the SWIFT test both more general as well as more informative, the counting of fully-wetted pavers was replaced with an approximation of the wetted surface area by assuming that it is roughly elliptical (circular if the surface is flat). Noting the constant ratio between an ellipse and a rectangle bounding it, the calculations were then further simplified by relating the wetted area to this rectangle. The infiltration rate could then be related to that measured by the Mod-ASTM through the use of Equation 1 determined from a plot of data points from previous PICP research conducted at UCT (Figure 4).

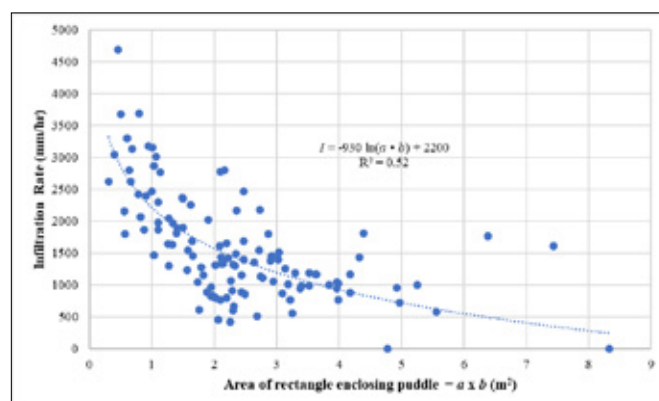
FIGURE 4: Mod-ASTM infiltration rate versus representative wetted area for the Mod-SWIFT test

$$I = 2210 - 930 \ln(a \times b) \quad (1)$$

I = Infiltration rate (mm/hr)

a = Length of longest wetted section (m)

b = Length of the longest wetted section perpendicular to a (m)

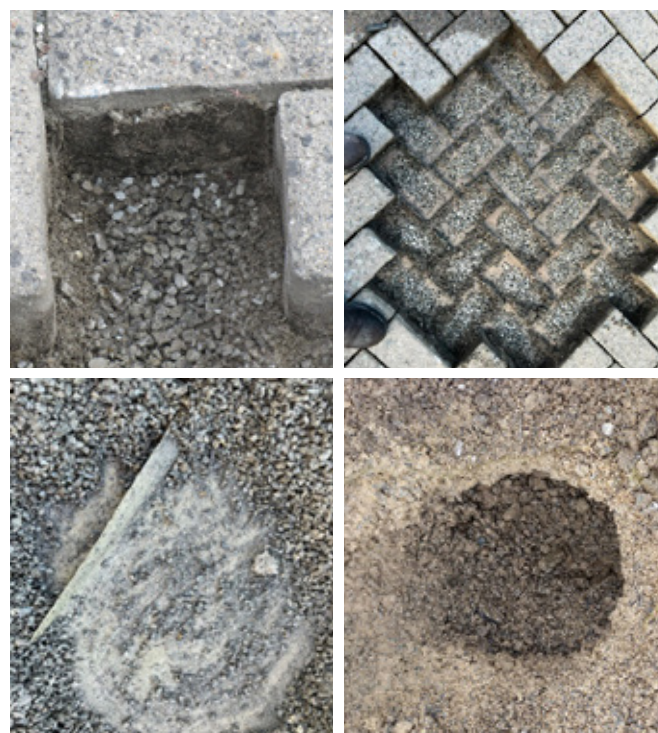
Four types of PICP clogging (Figure 5) were identified in the course of the diagnostic assessments:

- Type I clogging – the most common type – is when fine material fills the joints, typically the first 20 to 30 mm depth from the surface.
- Type II clogging takes the form of a sediment ‘wedge’ on the bedding layer immediately under the joints and usually looking like a silhouette of the paving pattern.
- Type III clogging is when the bedding layer and the top of any geotextile have been filled with sediment.
- Type IV clogging sees sediment throughout the full depth of the PICP layers (complete failure).

FIGURE 5: Different types of clogging: I (top left), II (top right), III (bottom left), IV (bottom right)

These are also in the rough order of occurrence – with Type I clogging being not only the first to take place but is also the most common by far, while Type IV clogging is the least common although it can be ‘built in’ during construction.
