PAPER 1

# THE REHABILITATION OF A PORTION OF JAKES GERWEL DRIVE USING RECLAIMED ASPHALT AGGREGATE FOR THE PRODUCTION OF BSM BASE

**Ian Bowker, Andrew Geel**

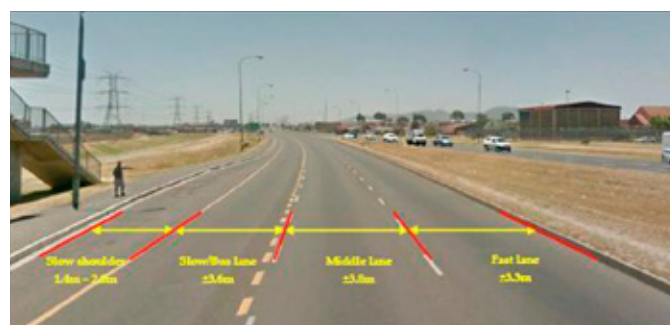
FIGURE 2: Typical northbound carriageway geometry

The road geometry typically consisted of three lanes in each direction, with a design speed of 60km/h and an average width of approximately 12m on each carriageway.

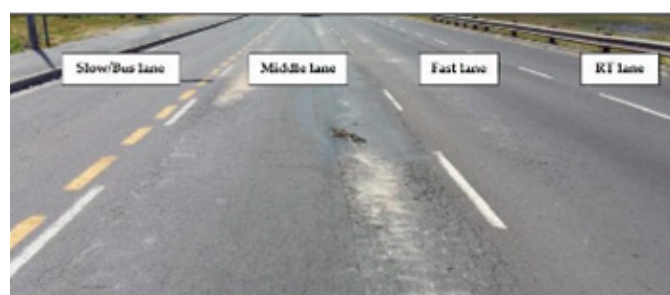
FIGURE 4: Crocodile cracking and pumping on northbound lane

- Degree 3 to 5 cracking along construction joints,
- Degree 3 to 5 crocodile cracking and associated pumping of fines,
- Degree 3 to 5 shoving and rutting of the asphalt wearing course.

Figure 4 below shows a typical example of the pavement condition.

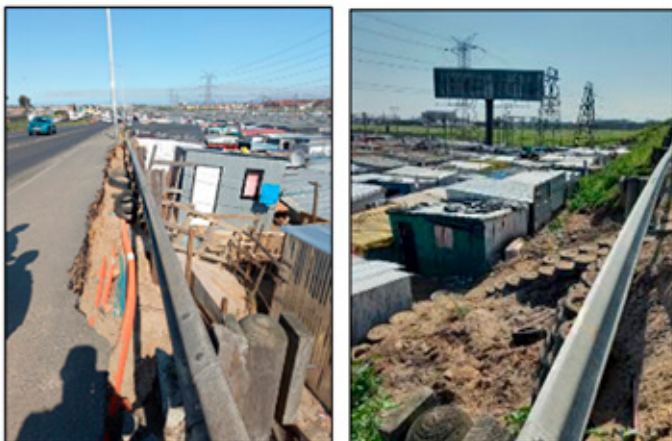
**FIGURE 7 & FIGURE 8:** *Encroachment onto fill embankment*

- An objective of the project that was not achieved was the repairing of a fill slope embankment approaching for a road-over-rail bridge. The need to repair the embankment was identified during the design stage, however during the tender period an informal settlement encroached onto the embankment, right up to the edge of the road. Negotiations with the community to allow for temporary relocations for the embankment to be repaired failed and no work could be carried out on the embankment. To avoid the possibility of damage to dwellings caused by heavy compaction equipment during the road rehabilitation process, the stretch of road adjacent to this community was constructed using static compaction, both for the BSM and the asphalt surfacing.
