# PAPER 5 B

# ASSESSMENT OF THE EFFECTIVENESS OF CONTAINMENT SUMP - SEWER SCREEN TO REDIRECT SEWER AND MICROBES' DOSAGE TO ENHANCED BIOREMEDIATION OF SURFACE WATER POLLUTION CAUSED BY COLLAPSE SEWER LINE, A CASE OF PROTEA SOUTH, COJ, SA.

Engineering Services Unit, Johannesburg Water

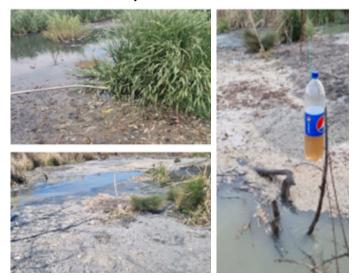
FIGURE 3: Showing raw sewer spill impcted area taken before construction and bioremediation.

Before bioremediation or the introduction of these technical measures, the collapse of the sewer pipe posed a significant threat to surface water quality, which posed serious ecological and public health concerns. During the bioremediation phase, the use of containment sump and sewer screens demonstrated a notable reduction in the presence of these contaminants. Post-bioremediation observation showed a marked decrease in levels of suspended solids and pathogenic bacteria, which aligns with the findings of similar studies (Mulligan et al., 2001). These improvements are critical for sustaining aquatic life and enhancing the overall health of the ecosystem. Sustained enhancements in the reduction of the impact on surface water quality post-bioremediation underscore the effectiveness of this bioremediation technique indicating healthier water conditions that can support diverse aquatic species (Pillay et al., 2016). The implementation of this method has demonstrated that, with regular maintenance and monitoring, the containment sump and microbial dosage can provide a sustainable solution for managing sewage spills and improving surface water quality.

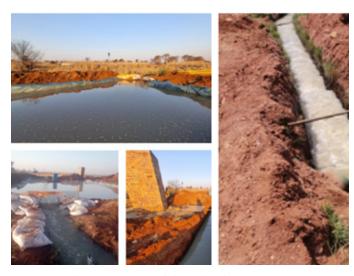
FIGURE 4: Showing constructed channel to direct wastewater to sump and from sump to river

Excavation was done at the selected site adjacent to the collapsed sewer pipeline to accommodate the sump and installation of a plastic sump structure to prevent the infiltration of the wastewater into the ground. Connect the sump to the existing sewer line by creating a channel to allow the wastewater/sewer to flow from the sewer pipeline towards the containment sump.

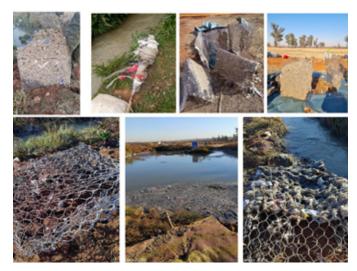
FIGURE 6: Showing waste water screens installed within the channel to trap solids before reaching the river

Placement of a stainless-steel screen at the sump outlet towards the channel that takes the wastewater from the sump to the river. The installation was

done strategically to filter out suspended rags and ensure the screen was securely fixed to prevent bypassing of solids.
