DRAWBACKS OF POTHOLE FILLING PROGRAMS AS A PREVENTIVE MAINTENANCE MEASURE: STUDY BASED ON NON-INTRUSIVE PAVEMENT DEFECTS INVESTIGATION

Christian A. MULOL

CSIR, Smart Mobility, Pavement Design and Construction

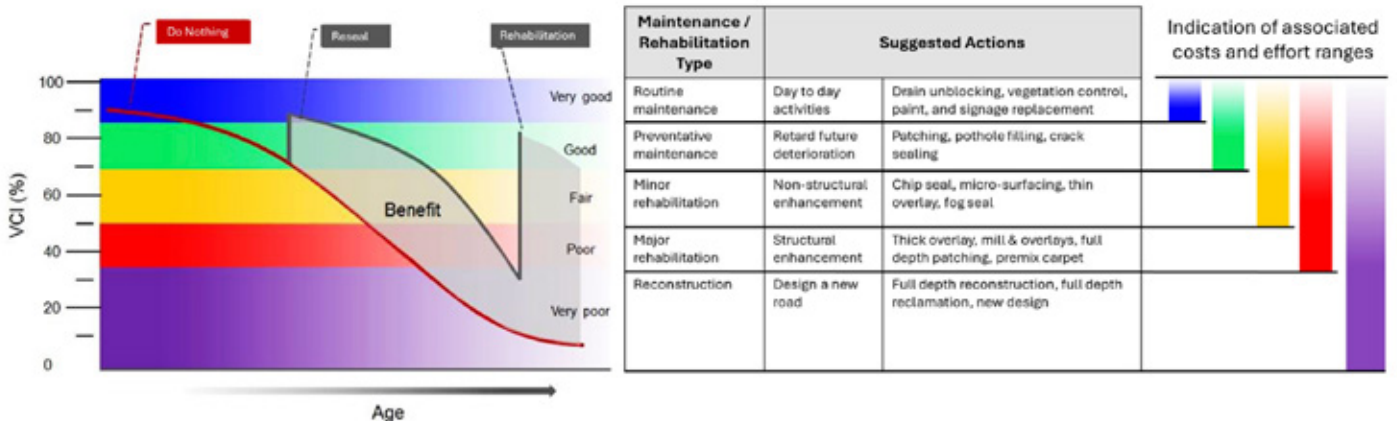
FIGURE 10: Pavement asset management: area under condition curve benefit.

rehabilitation approach would have been the optimal solution (see Figure 10 below). The risk is therefore that the same defect and hazardous conditions that were meant to be prevented would disappear temporarily, only to resurface within a matter of few years or months in some extreme cases.
