## PAPER 16

# WIDENING AND STRENGTHENING OF THE EXISTING CERES VAN BREDA BRIDGE

**Dave Edwards<sup>1</sup> and Joseph Barnard<sup>2</sup>**

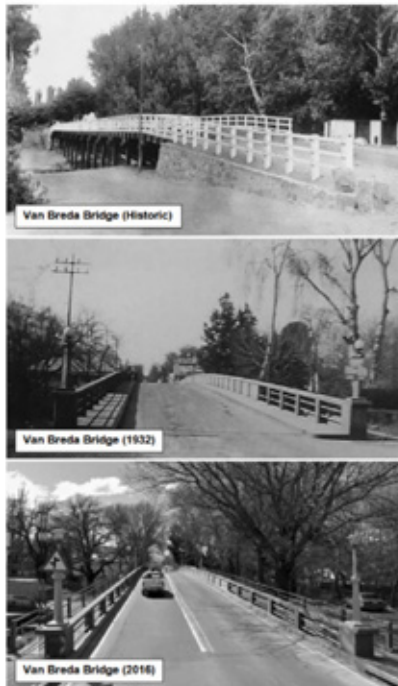
**FIGURE 2:** Historic Photographic Images of van Breda Bridge

The first bridge over the river was a wooden bridge built by Thomas Bain in 1885. This was replaced by the present concrete bridge in 1928, comprising seven simply supported spans, each 13.3m long at a 20° skew angle to align with the direction of the river. In 1950, it underwent widening the roadway width to 7.9m to accommodate increasing traffic, enough for two 3.9m wide lanes. Steel sidewalks, 1.65m wide, were added on both sides of the bridge. In 1993 structural rehabilitation was undertaken, including repairs of concrete deterioration and spalling, and the repair of timber planks on the walkways and the asphaltting thereof.

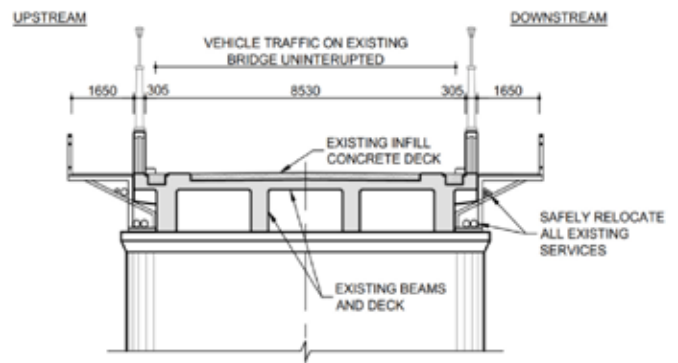
**FIGURE 4:** Typical section of existing van Breda Bridge

- To repair and enhance the riding quality of the surface, which had deteriorated over time. It was identified that the concrete topping slab was delaminating from the underlying beam structure.
- To widen the cross-section geometry of the bridge and accommodate two lanes with shoulders, and to provide space for cyclists and pedestrians.
- To increase the load capacity of the bridge to meet current standards. A 2013 investigation revealed that the structural capacity might have been as low as 66% of the TMH7 code requirement.
