PAPER 14

ADDRESSING VANDALISM AND WATER ISSUES IN LOW-COST, HIGH-DENSITY HOUSING PROJECTS

Karen King and Harry Neethling
RHDHV

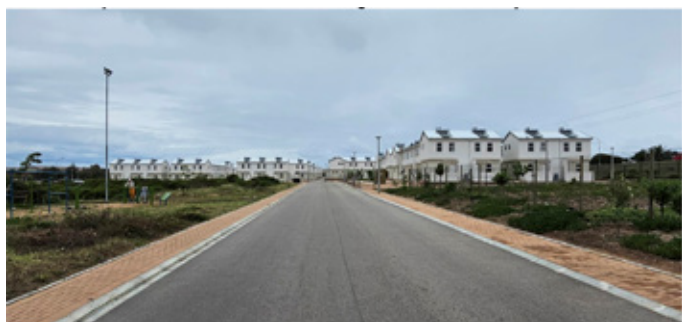
FIGURE 1: *The Mountain View Housing Development*

The Mountain View housing project (see Figure 1) was funded by The Western Cape Government, the (then) Department of Human Settlement and the Department of Energy. The land upon which the development was built previously belonged to the Mossel Bay Municipality and is a remainder of the Commonage. The houses built as a part of this development are on plots that have been transferred to the beneficiaries. The project was identified by the National Government as one of the catalytic projects for what is known as the Eden District of Mossel Bay. The land was previously a vacant stand. The beneficiary community members previously resided in backyards and informal neighbouring areas within the KwaNonqaba area in Mossel Bay. When identifying beneficiaries, the desired social profile for a housing development is roughly 30% fully subsidised houses and 70% partially subsidised houses. Preference is given to those living in backyards and to those 35 years of age and older, in accordance with the (then) Department of Human Settlements guidelines. In the Western Cape the previous Department of Human Settlements and Department of Public Works have merged to become the Department of Infrastructure.

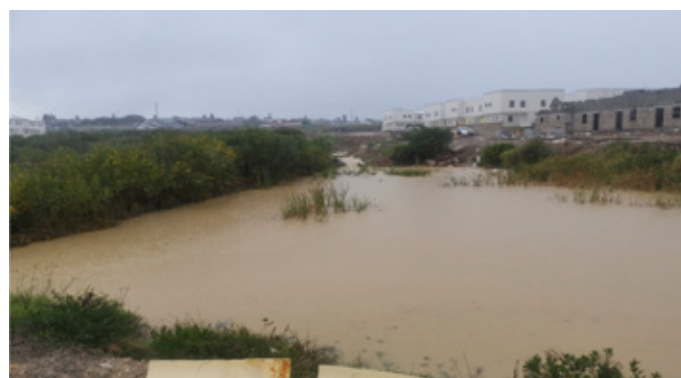
FIGURE 2: *Vegetated Detention Pond*

The total development water demand was calculated based on urban agriculture, sports field and school requirements in addition to the housing requirements. The stormwater management system comprises vegetated detention ponds (See Figure 2) integrated into public open spaces to make these dual-use areas. These open spaces provide communal gathering areas, improve the aesthetics of the development and capture and filter stormwater runoff, reducing the load on the drainage system and mitigating flooding risks. Stormwater caught in concrete drainage channels reports to the first of the vegetated detention ponds, from where it overflows into a curved natural channel into the second vegetated detention pond. From there it follows a natural stream bed toward the sea. Screens have been installed to catch larger pieces of debris and waste to prevent these from reaching the natural stream bed and the sea.

The rainwater harvesting systems are working well and the harvested rainwater is used for irrigation and washing cars. The water-saving low flow fixtures have contributed to reduced water consumption. The hybrid green-grey stormwater management solution of vegetated retention ponds and concrete channels have effectively mitigated potential flooding.

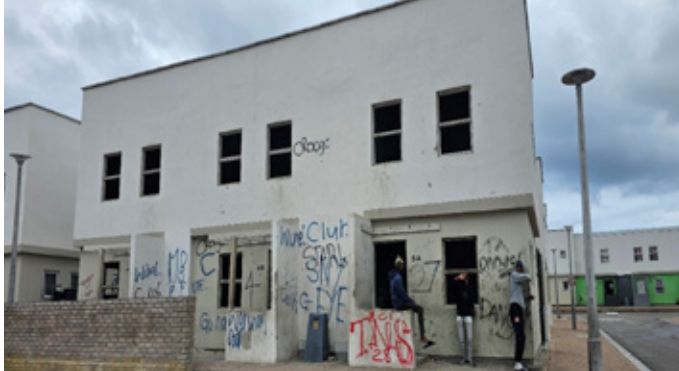
FIGURE 3: *Vandalised Houses*

Post occupation of the first batches of houses, the few remaining unoccupied houses were vandalised (see Figure 3). Community members that spoke to members of the project team said that those vandalising the Mountain View housing development came from within the Mountain View housing community. A community mural painting project using creative interaction techniques was facilitated to encourage relationship building between community members, and to provide opportunities for expression, community cohesion and a sense of belonging. This required knowledge on the part of the facilitators of community dynamics, and also of the local role players, such as Non-Governmental Organisations (NGOs) and Ward Councillors. Prior to starting the mural painting, three creative workshops were held with the community members, who ranged in age from 8 to 70. The first mural painting session was very successful, and the facilitators were warmly welcomed by the community and keen to take part in the project. The second painting session, although still viewed very positively by the majority of the community, was cut short by gang members demanding 'protection money' to allow the project to go ahead. As a result, the facilitators invited Khoi San Traditional Leaders from the area to take part in the third and final painting session. During this session a traditional ceremony was held to speak to the land and the ancestors of the land on which the Mountain View Housing Development had been

It is also key to note that a precursor to vandalism is often opportunity. The last few houses of the Mountain View development remaining unoccupied, once the others had been occupied, provided this opportunity.
